J. Asiat. Soc. Bangladesh, Sci. 46(1): 91-102, June 2020

# FIRE RISK SITUATION ANALYSIS IN THE NIMTOLI AREA OF OLD DHAKA

Key words: Fire hazard risk, Risk mapping, Nimtoli, Old Dhaka

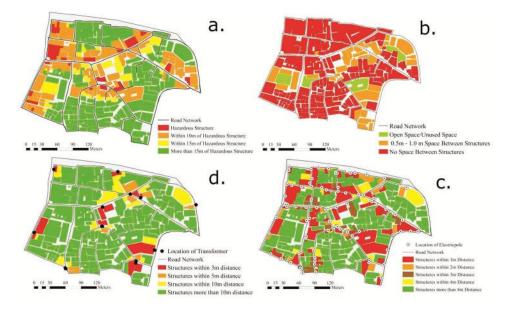
*Fire source and spreading of fire:* The hazardous structures are termed to those which have the potential to ignite and spread fire to other structures. From the field observation, the structure used as a hotel, *bakarkhani* shop (backer shop), and tea stall has been marked as hazardous structures. These hazardous structures can ignite a fire in this area. Structures within 10 m, 15 m, over 15 m distance of hazardous structures have been demarcated and termed them as high, moderate, low risk structures. A score of 3-0 have been assigned to these sub-factors according to risk (Table 1.). Score 3 has been given to the hazardous structures itself, and 2 - 0 score has been applied to the other structures (Table 1) and a risk map (Fig. 3a) is produced. There are 5.3% structures used as a hotel, tea stall, *bakarkhani* shop in Nimtoli area. The risk map reveals the fact that 30.36% of structures are at high risk, 8.7% at moderate risk and 55.6% at low risk.

Fig. 3. Showing a. hazardous structures, b. space between structures c. location of electric poles and d. location of transformers in Nimtoli area.

Proper space between structures is essential to keep building safe from spreading of fire from other structure. The nearest buildings always have a higher probability of catching fire from the affected buildings than the distant one. Construction rules amended by the government of Bangladesh in 1996 imposes conditions on setbacks, site coverage, plot usage, which ensures building safety during different hazards (Rahman *et al.* 2017). Setback defines the optimum distance that a structure should maintain from the adjacent road and other structures. For Dhaka city, a minimum 1.5 m space in front, 1 m space in backside and 0.8 m space in both sides must be kept for a plot size of two *katha* (1440 ft<sup>2</sup>) or less amount of land (GOB 2008). The study found that 90% of structures do not have any space between each other (Fig. 3b and Fig. 4). Only 10% have space 0.5 to 1 m (Fig. 3b) which has not followed the rules for all side of the plot. The structures with no space are scored as 2, and space with 0.5 - 1.0 m has been given score one (Table 1).

The electric poles have been marked in the study area during primary data collection (Fig. 3c and Fig. 4). Electric poles and cable can ignite the fire from a short circuit. Even if a fire occurs from other sources, electrical poles and cables can pose a risk for life and property. Electric cables are connected with individuals structures from the pole for electricity supply. A safe distance must be kept from an electric pole to avoid a fire incident. The buffer zones of 1, 2, 3 and 4 m from the electric pole are created to identify structures at risk for electric pole. The structure within 1, 2, 3, 4 and over 4 m are termed as very high, high, moderate, low, very low risk structures, and a score of 4 to 0 have been assigned (Table 1). Based on weights and score a risk map is produced (Fig. 3c). Underground electricity lines can increase fire safety and aesthetics of the area. Underground lines also can reduce damages of the electric supply system during the storm season.

Eleven transformers have been marked in the study area (Fig. 3d). The electric transformer is a dangerous source for a fire. A burst of a transformer can affect the nearest structures. The 2010 Nimtoli fire had started because of a transformer burst as claimed by some residents. To know the risk situation of the structures, several buffer zones are created from the transformer. During field observation, the study found that the location of transformers is very close to the buildings. So 3, 5, 10 m and more than 10 m buffer zone are created. Structures within 3 m, 5 m, 10 m and over 10 m have been marked as very high, high, moderate and low risk structures. Here rank value has been given from 3 (high risk) to 0 (low risk) (Table 1). All these information are used for producing a risk map for transformers (Fig. 3d). The study found that only 5.5% of structures are at high risk, 6% at moderate risk and 88.5% have a low risk because of the transformer.

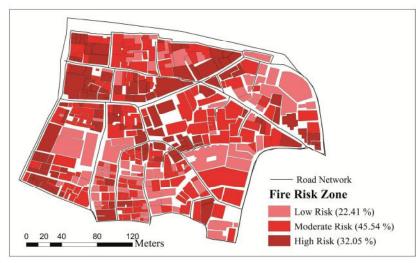
Fig. 6. Fire hazard risk map of Nimtoli.

All the structures have been categorized as severe, moderate and low risk in terms of eight risk factors (Table 4). The study found that 32% of structures are at high risk, 45.5% at moderate risk and rest of the structure at low risk (Fig. 6). The structure caught fire during the devastating 2010 Nimtoli tragedy still found as a high-risk structure for

In terms of fire safety, firefighting facilities, evacuation, rescue and first aid facilities, the Nimtoli area is still at risk of fire incidents. Mixed-use of structure and the business of wastage material must be regulated to reduce the fire risk of the study area. Electricity lines must be taken to the underground. Building code should be implemented strictly by government authority. Building owner and residents should ensure fire safety measure and firefighting drill to reduce fire risk in Nimtoli area. Identification of risky structure and issuance of warning is crucial. The government should take immediate legal action against those who are not taking any important initiatives after warnings from Bangladesh fire service and civil defence (BFSCD). Proper fire safety measures, regular maintenance of utility lines, awareness about fire hazards within the residents, proper implementation of Bangladesh national building code (BNBC), a regular safety inspection by Bangladesh fire service and civil defence, regulation of mixed-use of buildings can drastically reduce the fire risk in Nimtoli and other urban areas of Bangladesh.
