INVESTIGATION INTO THE CAUSES OF PREMATURE CORROSION OF PRE-FABRICATED STEEL FACTORY BUILDING

Abstract: Premature corrosion of steel roof panels of a prefabricated factory building was reported just two months' after installation. In order to find out the causes of this corrosion, physical investigation of the affected roof was carried out and samples of the panels and relevant information were collected. Laboratory tests were carried out on the samples using light optical microscopy, scanning electron microscopy (SEM), energy dispersive X-ray micro analysis (EDX) and tensile tests. Test results show that the steel roof was constructed from painted as well as Al-Zn coated steel sheet, conforming to ASTM A 792M Grade 340 and ASTM A 792M-A150. Analysis of other results suggests that the rusts were superficial in nature and they did not start from the steel sheet of the roof panels. Based on the superficial nature of the rust spots, their morphology, chemical analysis etc., it is believed that rust spots were caused by the corrosion of steel swarfs that deposited on the roof panels. The swarfs originated from drilling, cutting and riveting operations during installation. Proper clean

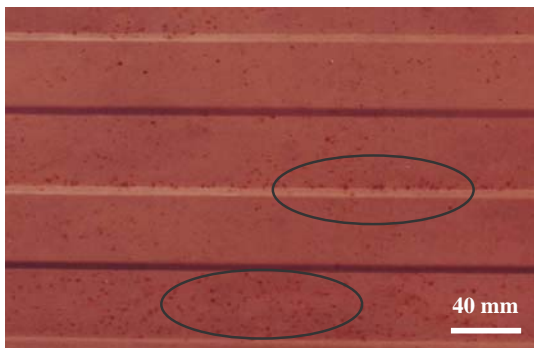
Although nothing much can be seen in the general view, close examinations reveal the presence of red-brown rust spots, most are about equal/less than one millimeter in diameter on the panels. The spots occur fairly wide over the whole roof. But the density of rust spots varies greatly: at most places the rust spot density is sparse, while at others the spots are more densely distributed. Figure 1 shows a view of rust spots as black spots on one of the affected areas.

Figure 1: Red-brown rust spots (appeared as black spots) occurring on a panel.

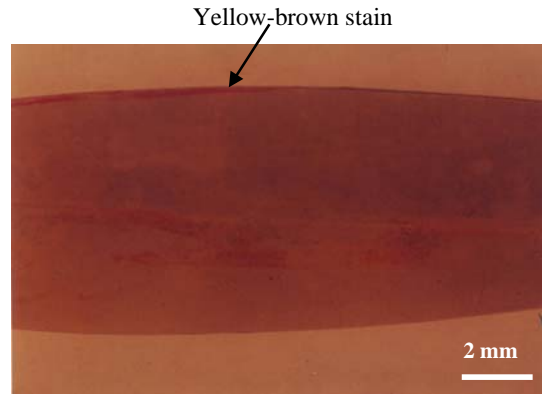
In addition to the rust spots, a number of elongated yellow rust stains were also found (Fig. 2). These are supposed to have been caused by loose steel bolts lying idle on the roof which were seen nearby during the physical investigation.

Figure 2: Elongated yellow-brown stains (appeared as dark area) on a panel caused by corrosion of loose bolts lying idle on the roof.

elongated rust stains (e.g., Fig. 2) showed that these are only superficial. The very presence of such rust stains, which are caused by corrosion of loose bolt lying idle on the roof, however, suggests the unawareness/ carelessness of the concerned installation/ maintenance personnel about the danger of improper cleaning of the roof panel.

Stain prevention is much easier and less expensive than repairing the stain caused by the steel debris. In severe cases, such staining can lead to replacement of the whole panels. Thus stain prevention is very important. There are several steps to preventing steel debris staining. The best method is to avoid formation of iron fines in the first place. When this is not possible, the exposed surface should be protected from debris generated during cutting, drilling or welding. Additionally, the panels need to be protected against tracking and finally all debris should be cleaned off the panels.

Careful sweeping is necessary as the job progresses to remove loose particles and particles not well embedded in the paint. Great care should be taken to avoid any action that is likely to remove the paint or metal when attempting to detach embedded debris. Any damage to these coatings will lead to a reduced life of the material. A bristle (nonmetallic wire) brush should be used to dislodge steel debris¹¹. Wire brushing can change the panel's appearance and might remove some of the metallic coating. If corrosion from the debris severely damages the metallic coating, affected areas may require painting to obtain the desired protection. Using any kind of steel wool will break up and create newly steel debris. Any steel particles that remain after cleaning will cause further stain. Larger iron pieces, such as

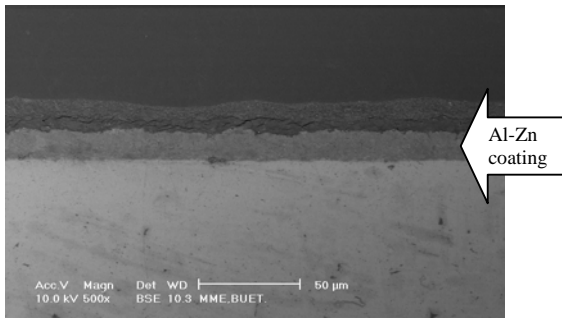
The above results show that the steel sheet used in the roof panel conforms to the specification ASTM A 792M Grade 340. A cross-sectional scanning electron micrograph of the roof panel material is shown in Fig. 3. The thickness of the aluminium-zinc coating is found to conform to ASTM A 792M-A150. The chemical composition of the galvanized coating obtained by EDX analysis also conforms to this specification. The EDX spectrum as well as chemical analysis of the aluminium-zinc coating is shown in Fig. 4. Both primer and top coat were also present on top of the aluminium-zinc coating.

Figure 3: Cross-sectional scanning electron micrograph of roof panel samples.

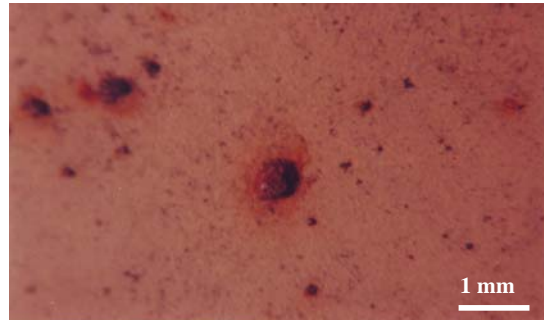
Stereo-microscopic investigation revealed that the rust spots on the panel generally consist of a central dark deposit surrounded by a lightly stained area (Fig. 5). Chemical analysis of the rust spots by EDX shows the presence of mainly iron and oxygen (Fig. 6). Some carbon, aluminium, silicon etc. were also present as contaminants; peaks of the latter two elements could also come from underlying aluminium-zinc coating. The central deposit of the rust spot was found to be brittle and could be easily removed mechanically with fingernail, which left only a thin dark patch.

building itself and/or as contamination from nearby steel buildings under construction. It is known from the literature¹¹ that fresh steel debris stains are small red-brown colored spots with a central dark spot. On bare panels, galvanic action protects the debris, possibly depleting the metallic coating in the immediate vicinity. An old steel debris stain appears as a smoother surface with a localized red-brown stain in the area where the steel particle corroded away. Iron fines from drilling cause groups of stain spots around the hole. Cutting often causes a line of stain spots along the cut. Tracked particles cause randomly dispersed spots on the roof.

Figure 5: Stereo-microscopic view of rust spot showing a central dark deposit surrounded by stain.

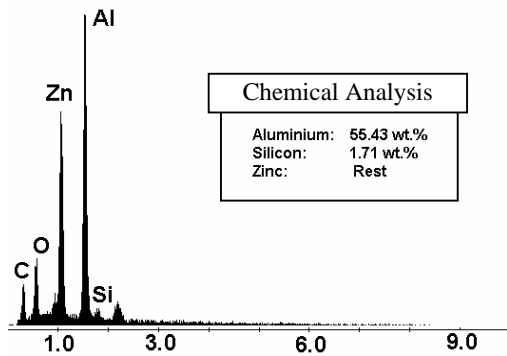
Figure 4: EDX spectrum and chemical analysis of aluminium-zinc coating [Carbon and oxygen are supposed to cause by contamination].

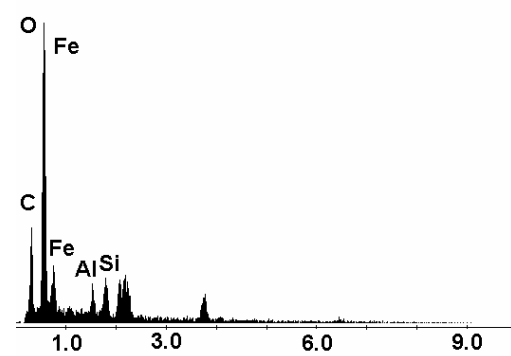
Figure 6: EDX spectrum showing iron and oxygen as the main constituent elements of rust spots.

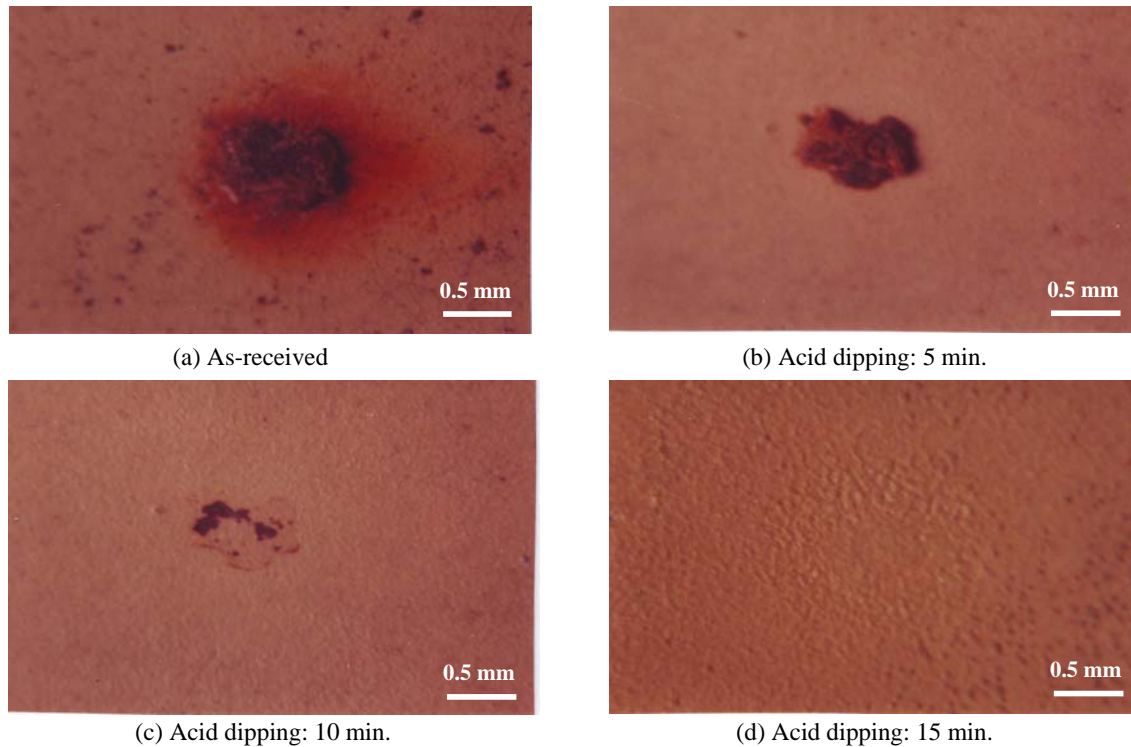
When treated with acid (10% dilute H_2SO_4) at room temperature, the deposit and the stain of the rust spots gradually disappeared (Fig. 7). After about 15 minutes dipping, the rust spots totally disappeared leaving no traces of rust on the paint. This suggests

that the rust is superficial. It is thought to have been caused by outside agent and not by corrosion product of the steel sheet of the roof panel itself. No sign of paint degradation was seen under the rust spots. This implies that the corrosion that started from outside has not yet penetrated the paint. Cross-sectional scanning electron microscopic investigations across different rust spots also corroborated this finding. The nature of the rust spots viz., their morphology, chemical analysis, superficial nature etc. suggests that these have been caused by corrosion of steel swarf. Steel swarfs, which are fine steel debris particles, usually originate from drilling, cutting, riveting operations during construction of the

Figure 7: Effect of acid treatment (10% H_2SO_4) on a rust spot: a) a rust spot in the as-received condition, b) the same spot after acid dipping for 5 min., c) acid dipping for 10 min., and d) acid dipping for 15 min. [Room temperature]
