J. Asiat. Soc. Bangladesh, Sci. 46(1): 91-102, June 2020

# FIRE RISK SITUATION ANALYSIS IN THE NIMTOLI AREA OF OLD DHAKA

Key words: Fire hazard risk, Risk mapping, Nimtoli, Old Dhaka

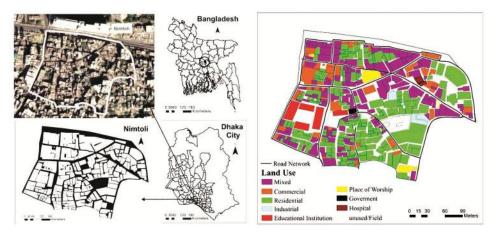
Fig. 2. a. Location and b. landuse pattern of structures in Nimtoli in old Dhaka. Source: Open street map and field survey 2018.

highly sensitive to fire. Buildings used for commercial purpose are not equipped with fire protection measures. Many commercial buildings are used as shops, hotels, restaurants and a baker shop. The field survey observed that number of open spaces is minimal in Nimtoli area (Fig. 2b). It is important to note that there are no water bodies and fire
